## **Flexural behavior of reinforced masonry panels**

Juliana T. Oliveira, Joaquim O. Barros

Report 02-DEC/E-10

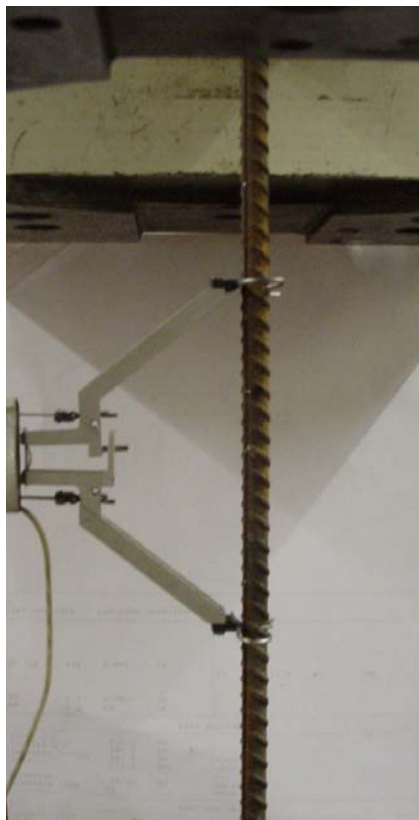
Figure 1 – Device used for measuring the strain of the steel bar specimen.

A clip-gauge was used to measure the displacements up to the estimated material limit of proportionality, LOP, see Figure 1. For avoiding the damage of the clip

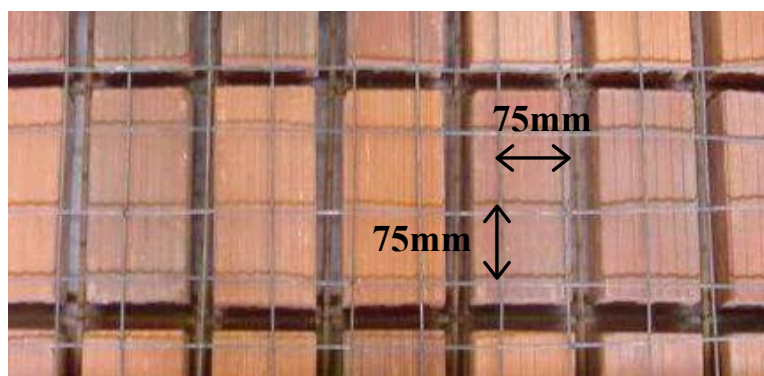
Figure 2 – Detail of the welded wire mesh.

A welded wire mesh A500 with the tradename of CQ30 was used to reinforce the concrete layer of the masonry panels. The wire mesh was placed at the brick-concrete layer interface. This mesh was composed by wires of 3 mm diameter forming a square grid of 150 mm edge. As the desired wire spacing was 75 mm, two over-crossed CQ30 meshes were applied for reinforcing the concrete layer (see Figure 2).

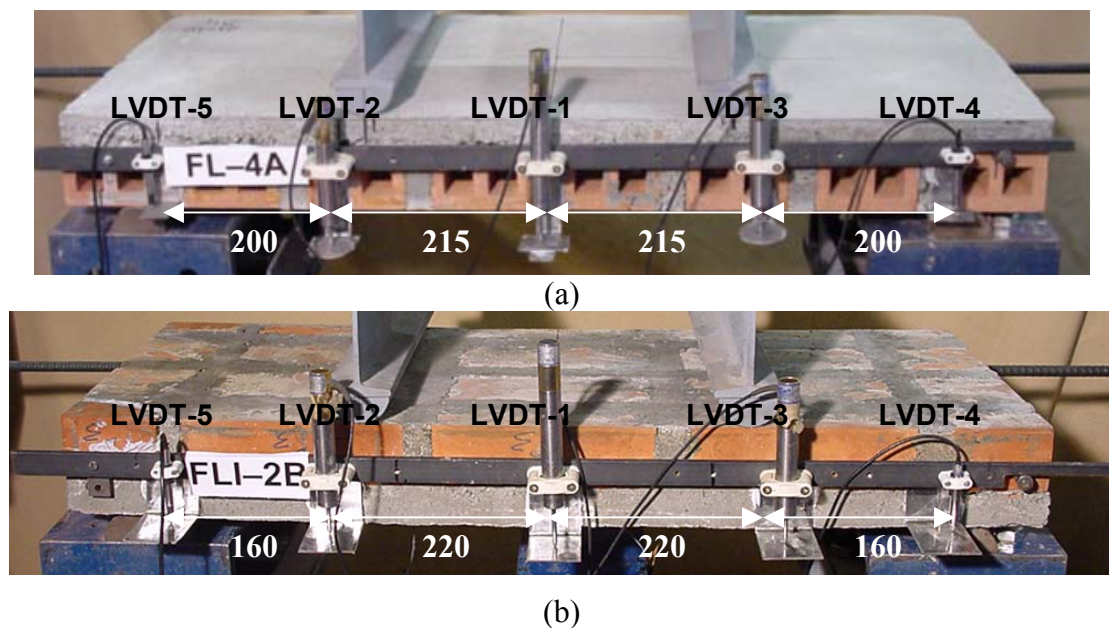
Figure 4 – Arrangement of the displacements transducers (LVDT) in the panels of series FL-A (a) and FLI-B (b). Dimensions in mm.

Five displacement transducers (LVDTs), placed according to Figure 4 (a) and (b), were used for measuring the panel deformability. In panels of series -A, a LVDT was placed at mid span (LVDT1), two LVDTs near the line loads and distanced 215 mm from the panel center (LVDT2 and LVDT3), and two LVDTs near the external supports, distanced 415mm from the panel center (LVDT4 and LVDT5). In panels of series -B, a LVDT was placed at panel mid span (LVDT1), two LVDTs near the line loads and distanced 220 mm from the panel center (LVDT2 and LVDT3) and two LVDTs near the external supports and distanced 380 mm from the panel center (LVDT4 and LVDT5). The differences in the positions of the LVDTs in series –A and –B are due to the different length of the corresponding panels. The tests were grouped in the following series:

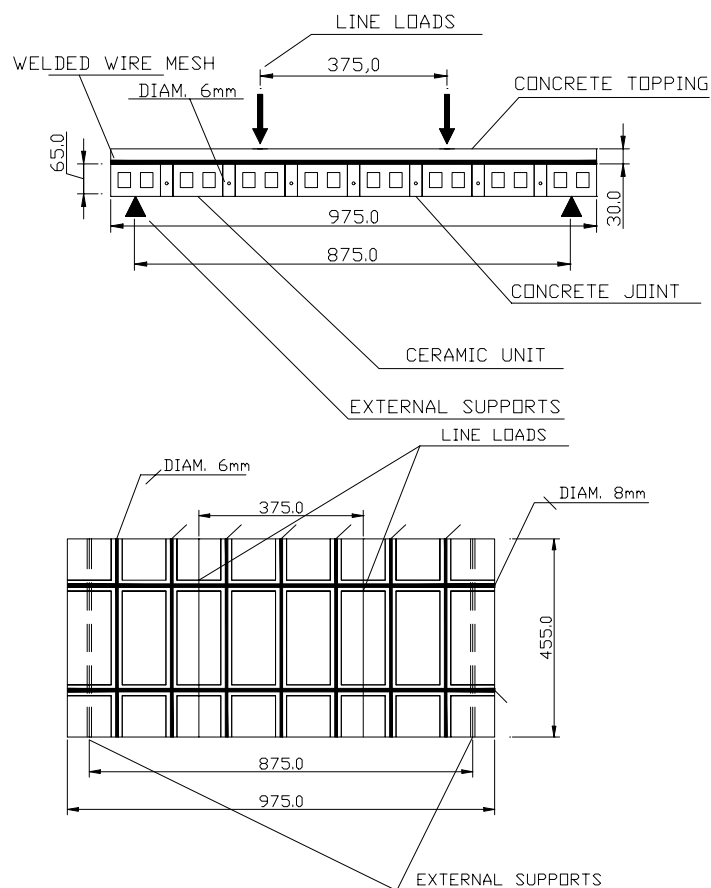
Figure 5 – Panel dimensions, loading arrangement and support conditions on panels of series A.

A masonry specimen was composed by ceramic bricks, concrete joints, concrete layer, welded wire mesh and steel bars. A masonry panel had the dimensions of 975 mm length, 455 mm width and 95 mm thickness. The panel entire thickness was composed by the brick thickness (65 mm) plus the concrete layer thickness (30 mm). The force was applied by two line loads in the specimen's width, distanced 187.5 mm from the middle of the panel. In two series this distance was increased, in order to force the occurrence of shear failure. The external supports were distanced 437.5 mm and 420 mm from the panel center (see Figures 4, 5 and 6).

The loading arrangement of series FLC was defined with the purpose of induce shear failure mode. Details of series -A and -B are represented in Figures 5 and 6. The test layout is shown in Figure 7.

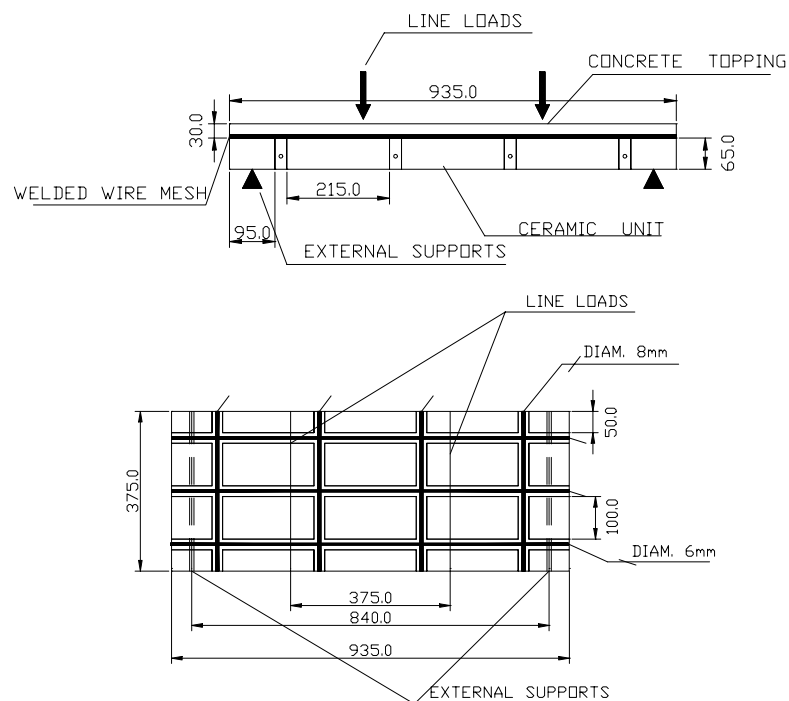
Figure 6 - Panel dimensions, loading arrangement and support conditions on panels of series B.

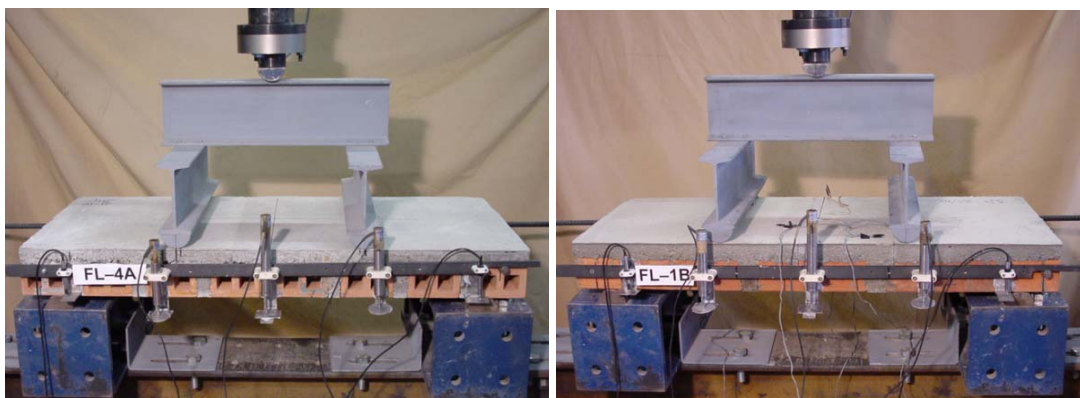
Figure 7 - Test system for panels of series -A and -B.

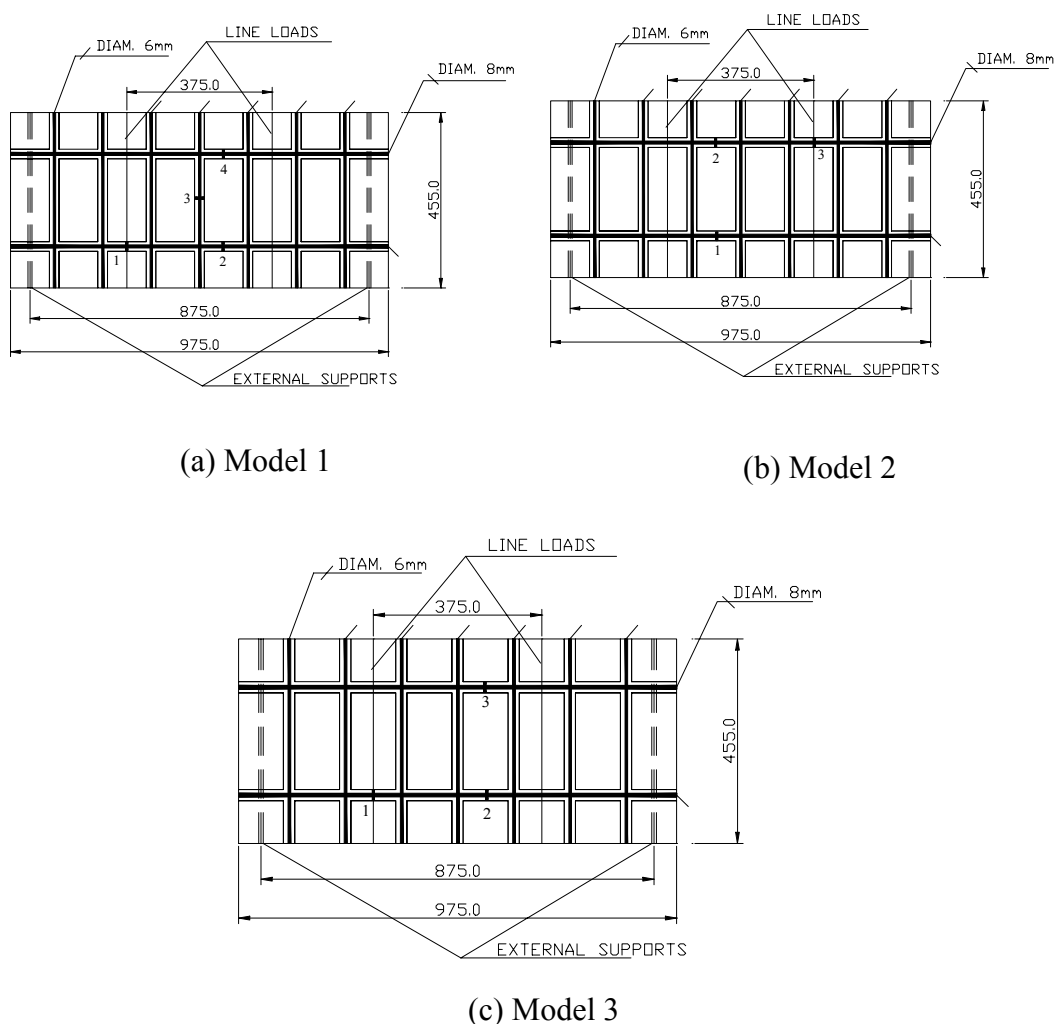
Figure 8 – Positions of the strain gauges used in series FL-A and FLI-A.

To obtain information about the deformational behavior of the steel bars reinforcing the masonry panels, strain gauges of  $120\ \Omega$  resistance were glued to some bars, according to the scheme represented in Figures 8 and 9.

Panel reference	Configuration of strain gauges
FL-3A	Model 2 (Figure 8)
FL-1B	Model 2 (Figure 9)
FL-2B	Model 4 (Figure 9)
FL-3B	Model 5 (Figure 9)
FLI-1A	Model 2 (Figure 8)
FLI-2A	Model 1 (Figure 8)
FLI-1B	Model 1 (Figure 9)
FLI-2B	Model 2 (Figure 9)
FLI-3B	Model 3 (Figure 9)

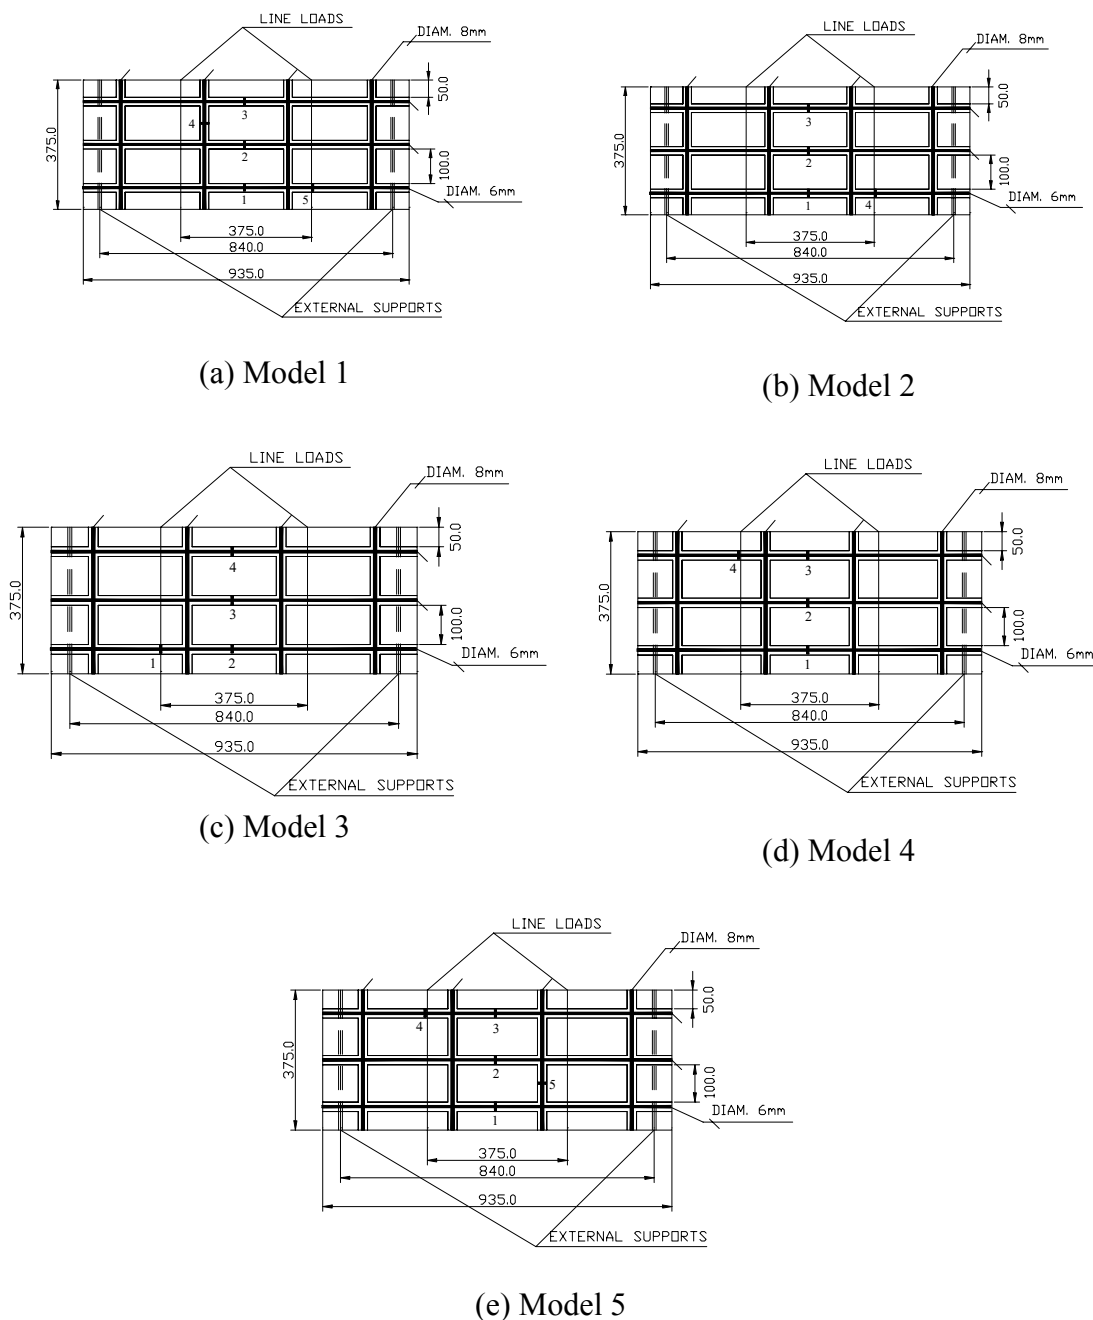
Figure 9 - Positions of the strain gauges used in series FL-B and FLI-B.

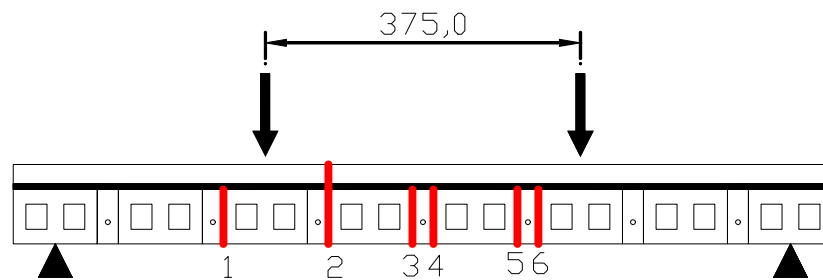
Figure 10 – Crack pattern in FL-1A.

At a load of about 34 kN, the six fissures depicted in Figure 10 have arisen almost simultaneously at the concrete/brick interface. After this load level and during the crack opening process of the fissures, the welded wire mesh began rupturing. Fissure 2 was the failure crack, and a crack opening of 15 mm was attained on the brick base, and 10 mm on the brick/concrete layer interface. At a load of 44 kN fissure 2 crossed the concrete layer and the panel load bearing capacity began decreasing, as Figure 11 shows.

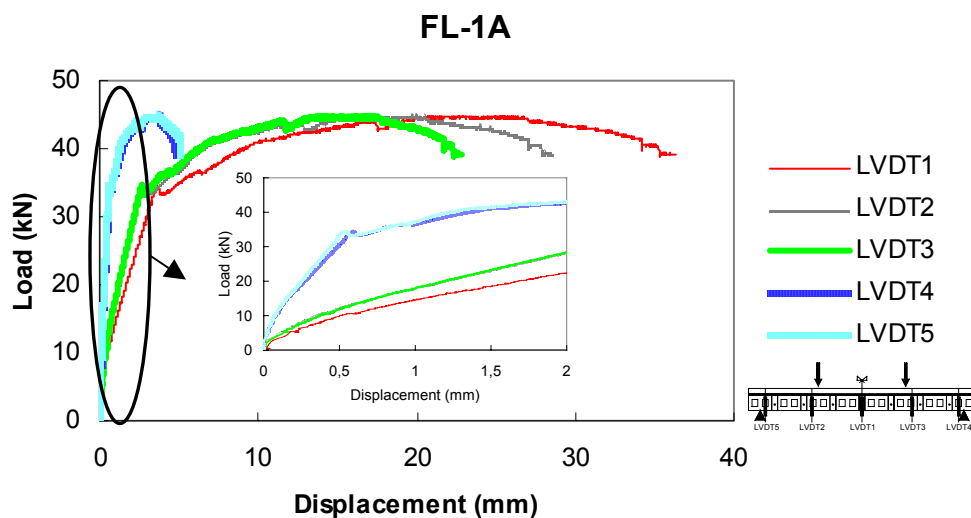
Figure 11 – Force-displacements relationship for all LVDTs.

In spite of LVDT2 and LVDT3 are symmetrically placed (see Figure 4), LVDT 2 registered larger displacements because it is located nearest the failure crack. The displacements near the external supports of the panel were similar. Figure 12 shows the panel at the moment of its failure. The concrete above fissure 2 (failure crack) has crushed.

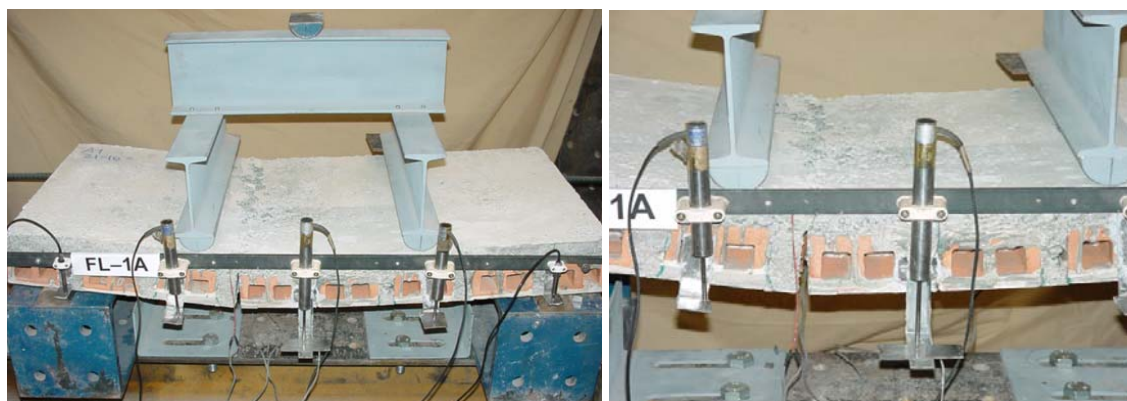
Figure 12 – Aspect of the panel FL-1A after have been tested.

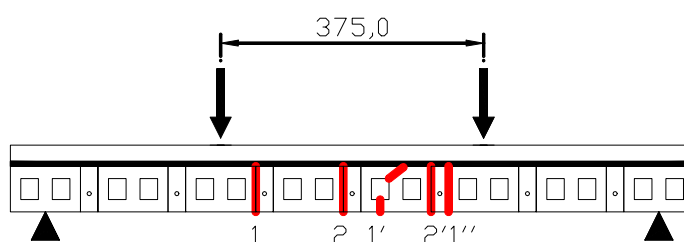
Figure 13 - Crack pattern in FL-2A.

Fissures 1, 1' and 1'' (see Figure 13), at brick/concrete interface, appeared at a load of about 30 kN. The others fissures occurred at a load of about 40 kN. The fissures occurred in the alignment of the brick hole (fissure 1'), and at concrete joint/brick interface. At failure and at panel bottom surface, fissures 1' and 2' had an average crack opening of 7 mm.

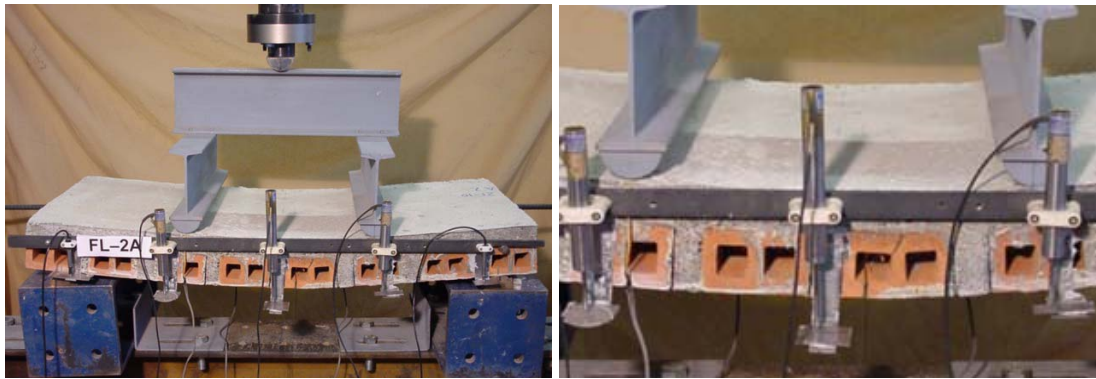
Figure 14 - Aspect of the panel FL-2A after have been tested.

Due to a problem with the data acquisition system, the displacements measured by the LVDTs were not recorded. However, the behavior of this panel was similar to the panel FL-1A, except concrete crushing that was not occurred in panel FL-2A. A view of the panel after have been tested can be seen in Figure 14.

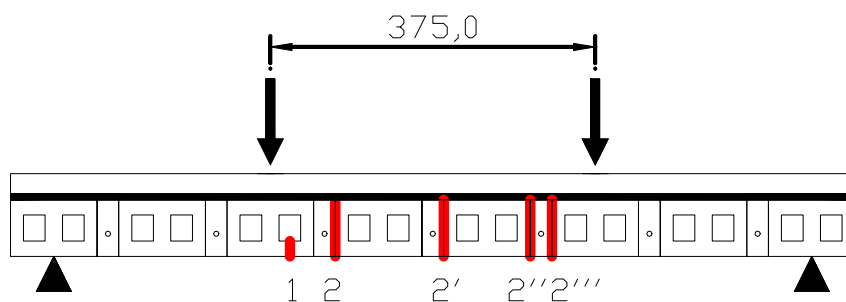
Figure 15 - Crack pattern in FL-3A.

Fissure 1, in the alignment of a brick's hole, was the first fissure to appear, at a load of 8 kN, see Figure 15. Fissures 2, 2', 2'' and 2''' occurred simultaneously at a load of about 34 kN, see Figure 16. The major crack opening was observed in fissures 1 and 2'''. At the end of the panel test it was measured the crack opening of fissure 2''' at panel bottom surface, having registered a value of 7 mm in panel back side and 3 mm in panel front side. In this case, the panel was more loaded in its back side. This fact can be also verified by the values registered in strain gauges, see Figures 18 and 19. Strain gauge 2 (see model 2, Figure 8), placed in panel rear zone, measured larger strains than strain gauge 1, placed in panel front zone.

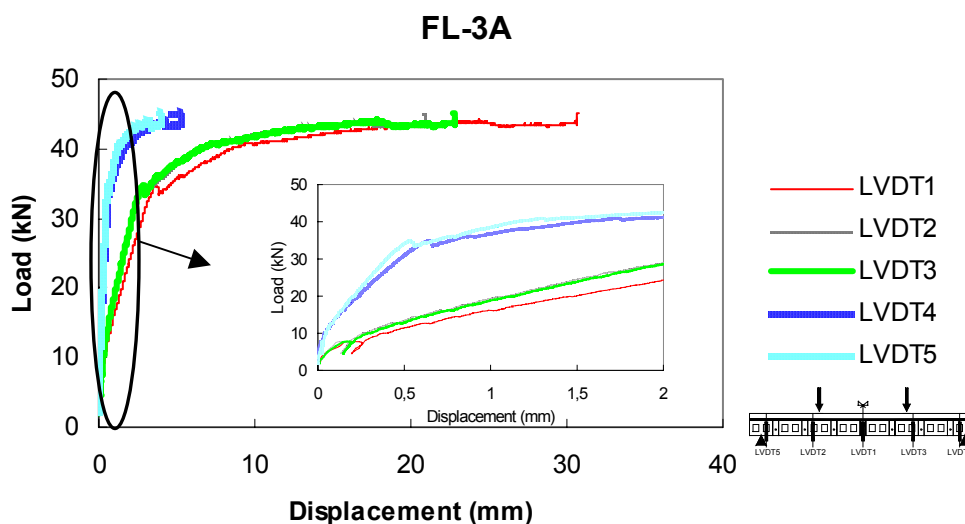
Figure 16 - Force-displacements relationship for all LVDTs.

Due to a quasi-symmetric distribution of the fissures, LVDTs 2 and 3 registered similar displacements, see Figure 16. However, as fissure 2''' developed the larger crack opening, LVDT3 registered displacements slightly higher than LVDT2. LVDTs near the supports measured similar displacements. The panel appearance after have been tested is shown in Figure 17.

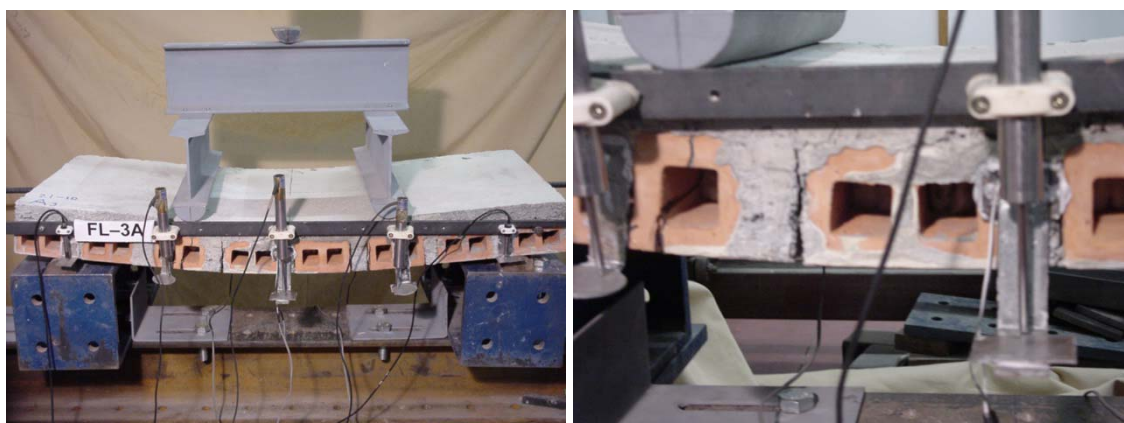
Figure 17 - Aspect of the panel FL-3A after have been tested.

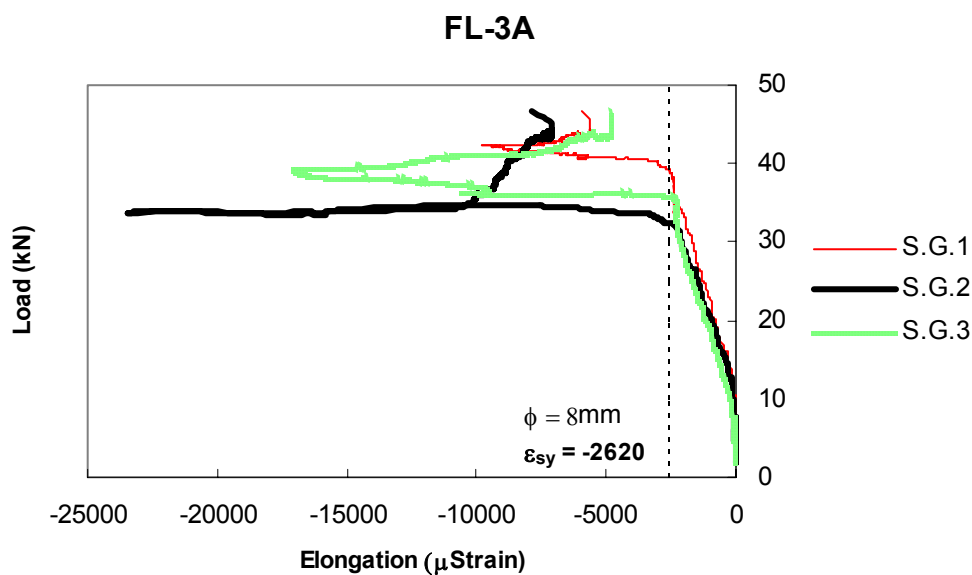
Figure 18 – Force-strain relationship for all strain gauges.

Analyzing Figure 18 it is verified that longitudinal steel bars have yielded at a strain of about  $2.6 \times 10^{-3}$ , in agreement with the yield value registered in uniaxial tensile tests (see Annex 1). Taking the force values corresponding to the yield initiation of longitudinal bars it is verified that the longitudinal bar at panel rear zone has yielded before the bar at panel front zone.

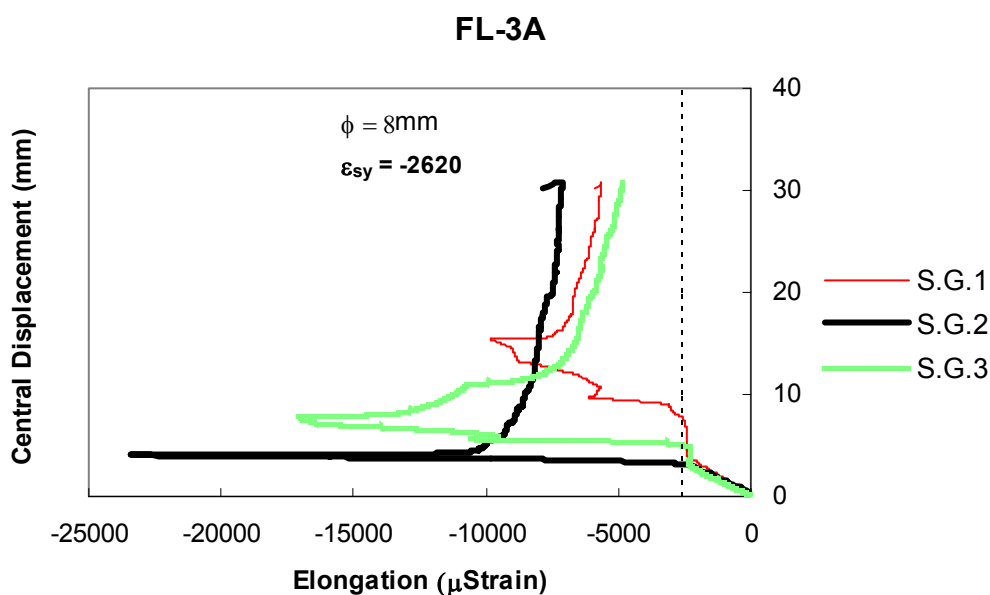
Figure 19 – Relationship between the deflection at panel mid span and the strains at strain gauges.

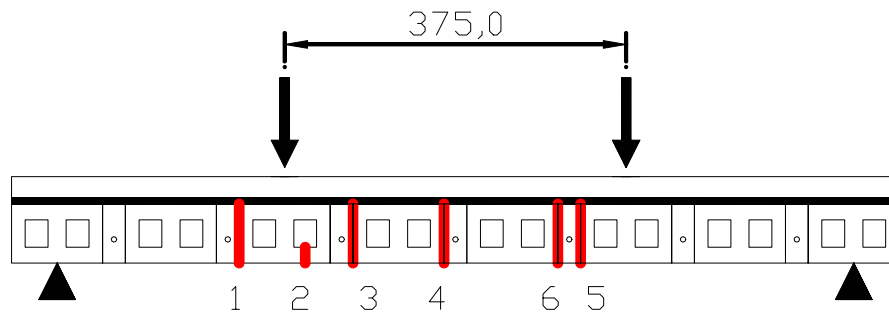
Figure 20 - Crack pattern in FL-4A.

The first fissure (fissure 1) occurred at a load for about 7 kN. Fissures 2 and 3 appeared almost simultaneously at a load of about 17 kN, while fissures 4 and 5 occurred at a load of 38 kN, see Figure 20 and graphic presented in Figure 21. Finally, fissure 6 appeared at a load of about 50 kN and became the failure crack. The crack

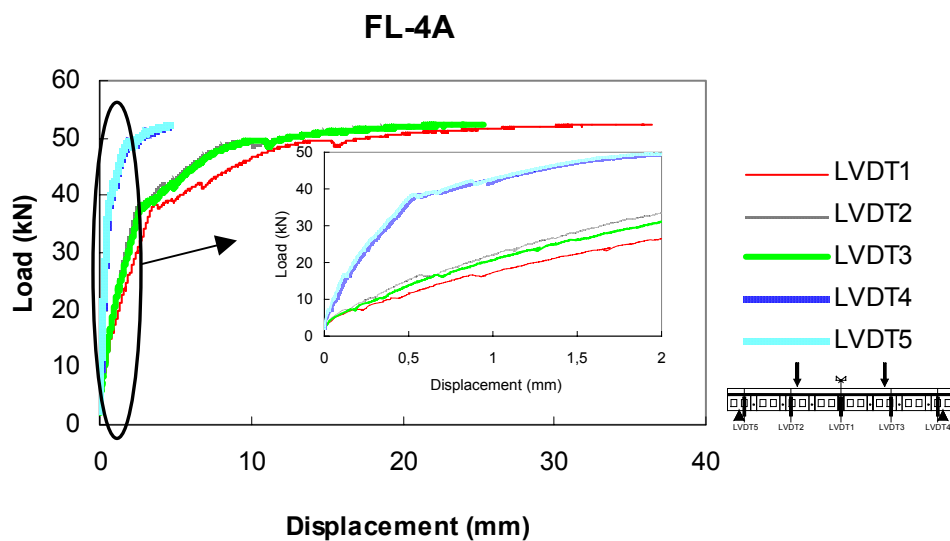
Figure 21 - Force-displacements relationship for all LVDTs.

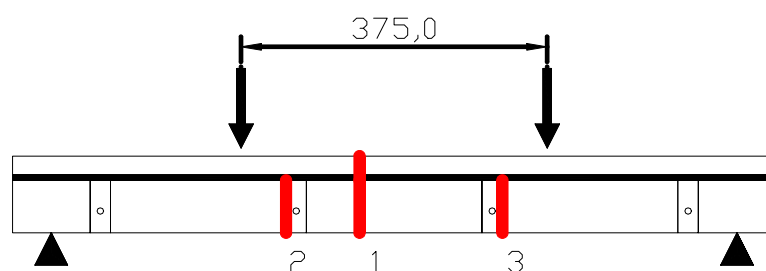
Figure 23 - Crack pattern in FL-1B.

The first fissure observed in this panel occurred in the brick at panel mid span (fissure 1), at a load of 24 kN, see Figure 23. This fissure has crossed the panel width. Fissures 2 and 3 occurred in sequence, at brick/joint interface at a load of about 36 kN and 43 kN, respectively. At a load of 52 kN fissure 1 (the failure crack) has opened significantly.

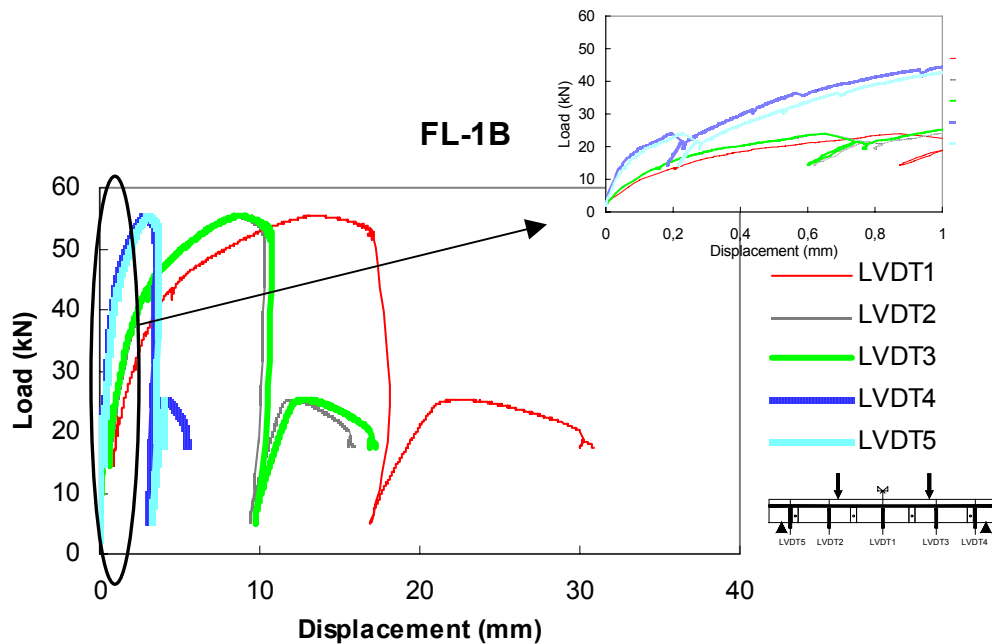
Figure 24 - Force-displacements relationship for all LVDTs.

The largest deflection was measured by the LVDT1. The LVDTs placed symmetrically registered similar displacements, see Figure 24. Figure 25 illustrates the aspect of the panel after have been tested.

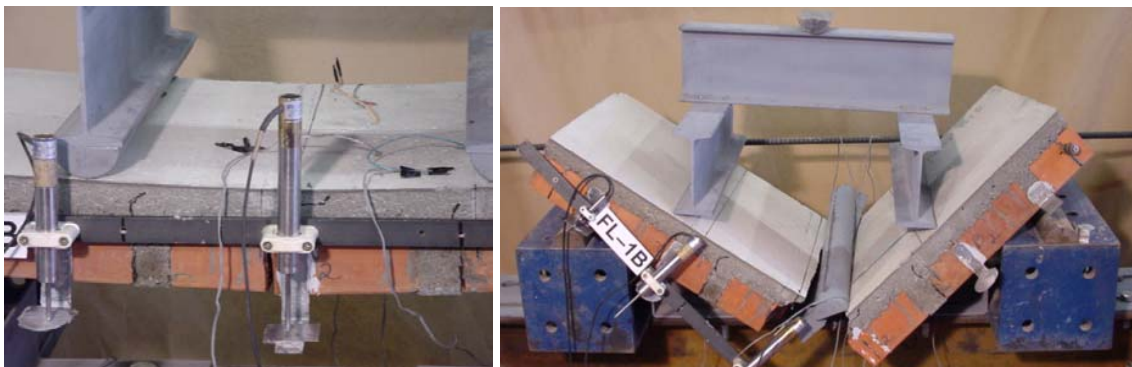
Figure 25 - Aspect of the panel FL-1B after have been tested.

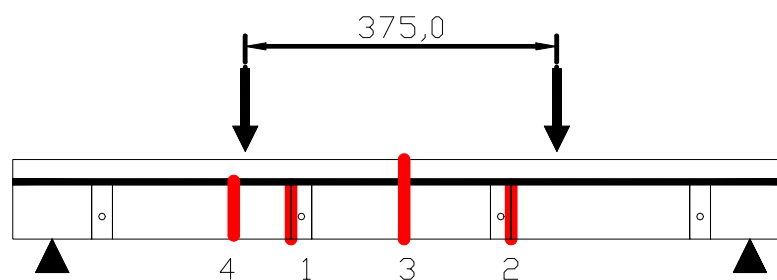
Figure 26 - Crack pattern in FL-2B.

In this panel four fissures occurred, positioned according to the scheme represented in Figure 26. Fissures 1 and 2 became visible at brick/joint interface at a

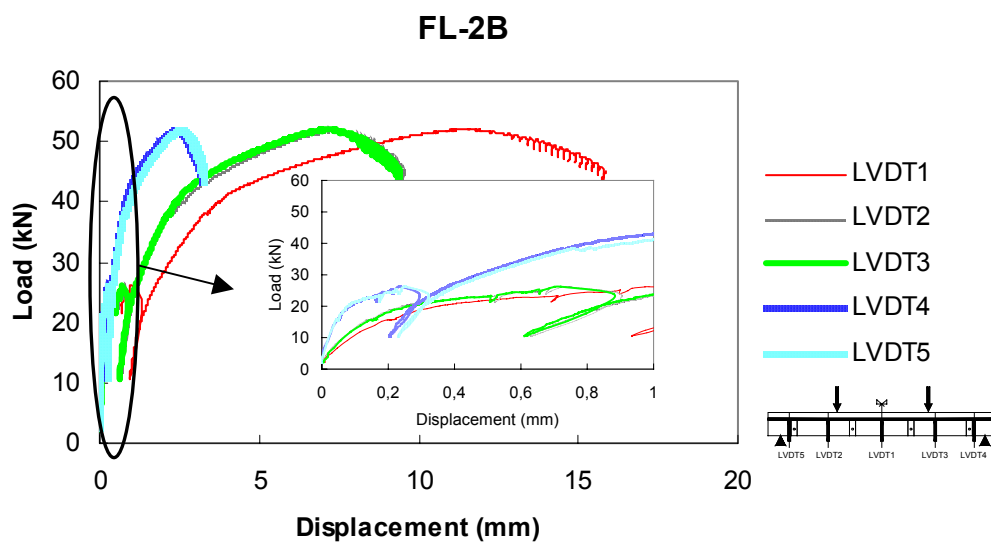
Figure 27 - Force-displacements relationship for all LVDTs.

load of about 16 kN, while the other two fissures have crossed the brick units. At a load of 23 kN fissure 3 occurred and became the failure crack. At a load of 26 kN the crack opening of fissure 3 increased significantly. At this load level fissure 4 appeared, crossing the brick placed in the panel left shear span, near the line load. At about 40 kN the longitudinal reinforcement (6 mm diameter) started to yield. Considering the force values when strain gauges registered the yield initiation (see Figure and Figure ), it can be concluded that central bar was the first one to yield. At a load about 52 kN the crack opening of fissure 3 was 10 mm and 2 mm at panel bottom surface and at concrete layer bottom surface, respectively. At panel back side the corresponding values of crack opening were 7 mm and 2 mm. At this load level the longitudinal reinforcement crossing this fissure has ruptured. The displacements of the LVDTs positioned symmetrically were similar.

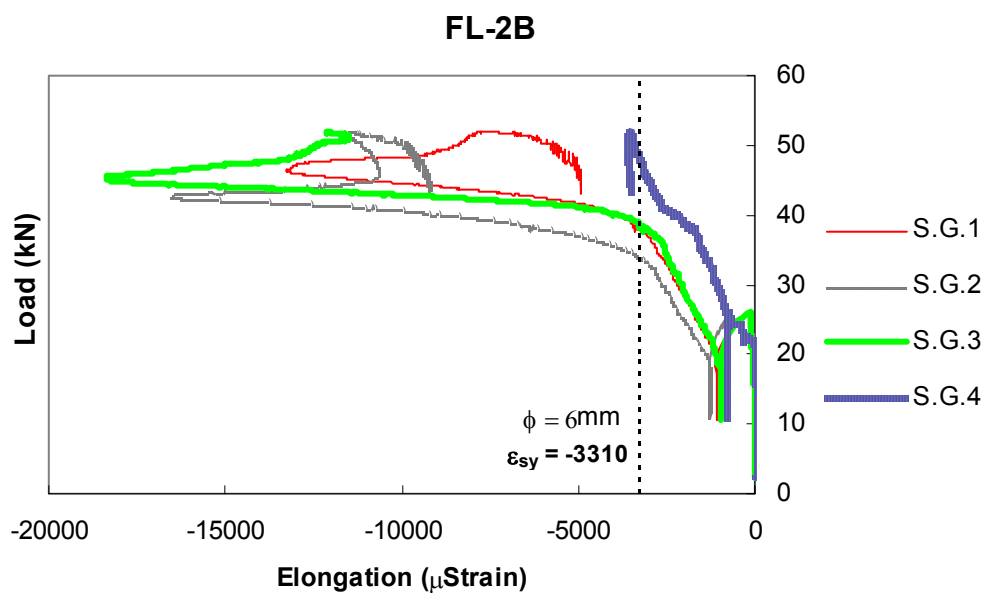
Figure 288 - Force-strain relationship for all strain gauges.

In this panel four strain gauges were applied according to the model 4, see Figure 9. The longitudinal reinforcement had linear behavior until an elongation near  $3.31 \times 10^{-3}$  (see Figures 28 and 29), which is in agreement with the results obtained in tensile tests carried out with steel bars of 6 mm diameter. When fissure 3 has occurred, at about 23 kN, a significant increase of strain was registered in strain gauges 1, 2 and 3, placed at panel middle span, glued to longitudinal bars. At about 43 kN these strain gauges registered a decrease of strain when the load was increasing. This was due to the occurrence of slip between the longitudinal bars and concrete, at fracture process zones.

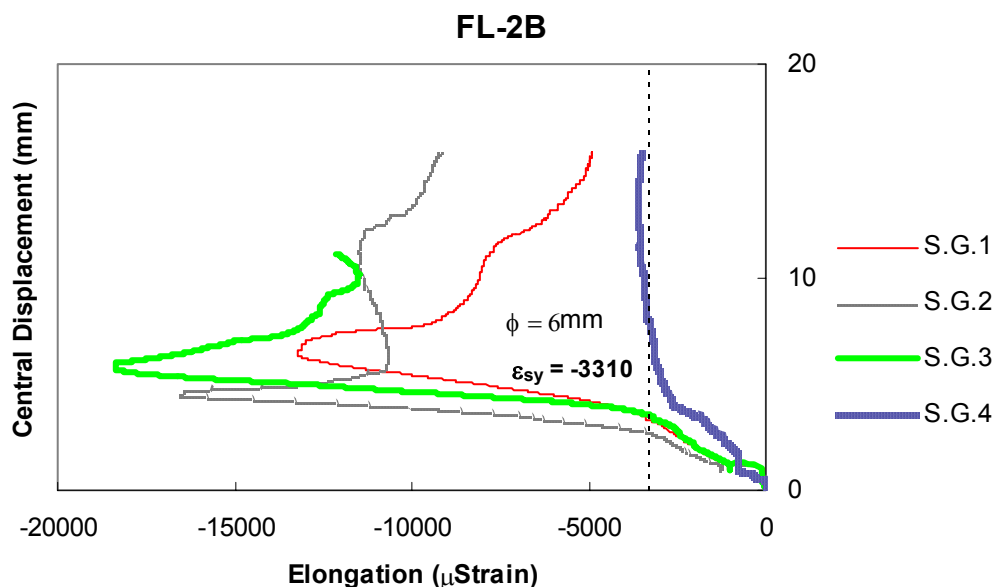
Figure 29 - Relationship between the deflection at panel mid span and the strains at strain gauges.

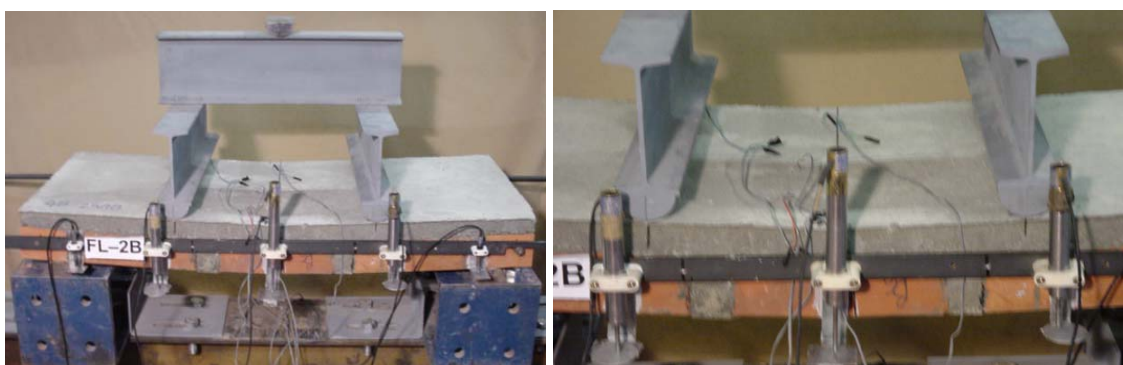
Figure 30 - Aspect of the panel FL-2B after have been tested.

Figure shows the aspect of the panel after have been tested.

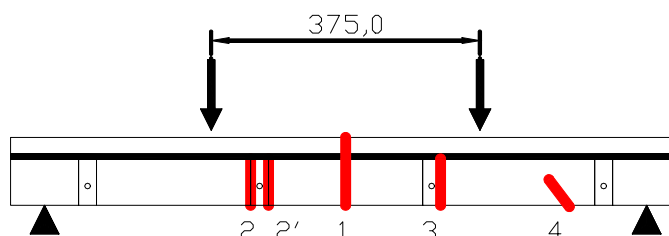
Figure 29 - Crack pattern in FL-3B.

In this panel, the first fissure (n. 1, see Figure 29) became visible at panel mid span for a load of 27 kN having induced a load decay. Fissures 2 and 2' appeared simultaneously at brick/concrete interface at a load of 42 kN. While fissure 1 was widening, a shear crack arose in the brick at the left shear span of the panel (fissure 4), at a load of 49 kN. The occurrence of this crack has dropped the panel load bearing capacity to a load of 38 kN. The final configuration of the fissures is represented in Figure 29.

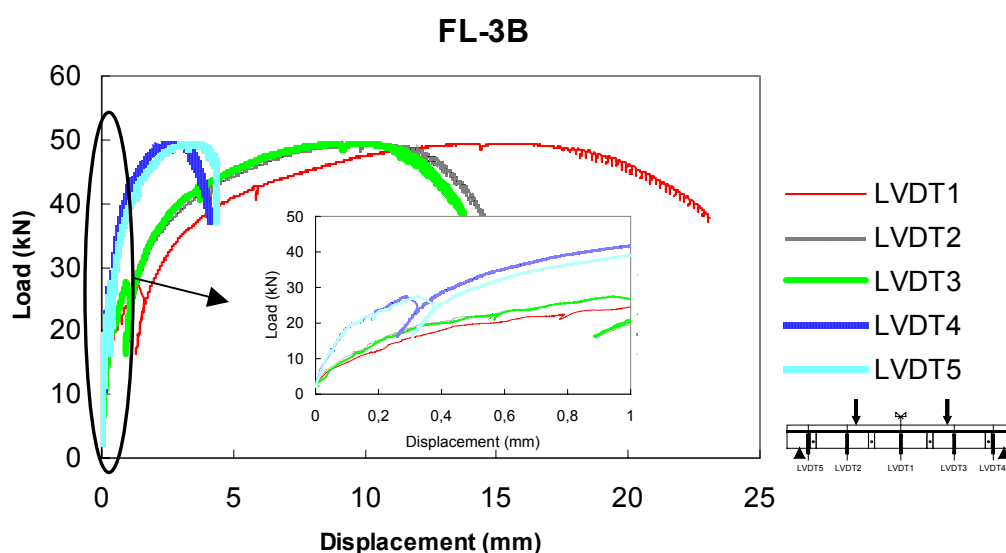
Figure 30 – Force-displacements relationship for all LVDTs.

As Figure 30 reveals, the displacements registered in the LVDTs placed symmetrically were similar.

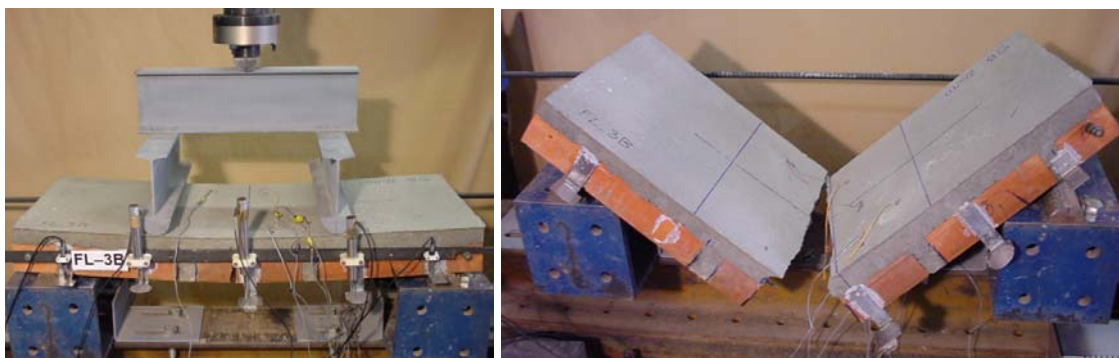
Figure 31 - Aspect of the panel FL-3B after have been tested.

The failure configuration of panel FL-3B is shown in Figure 31. The longitudinal bars ruptured at the failure crack (fissure 1).

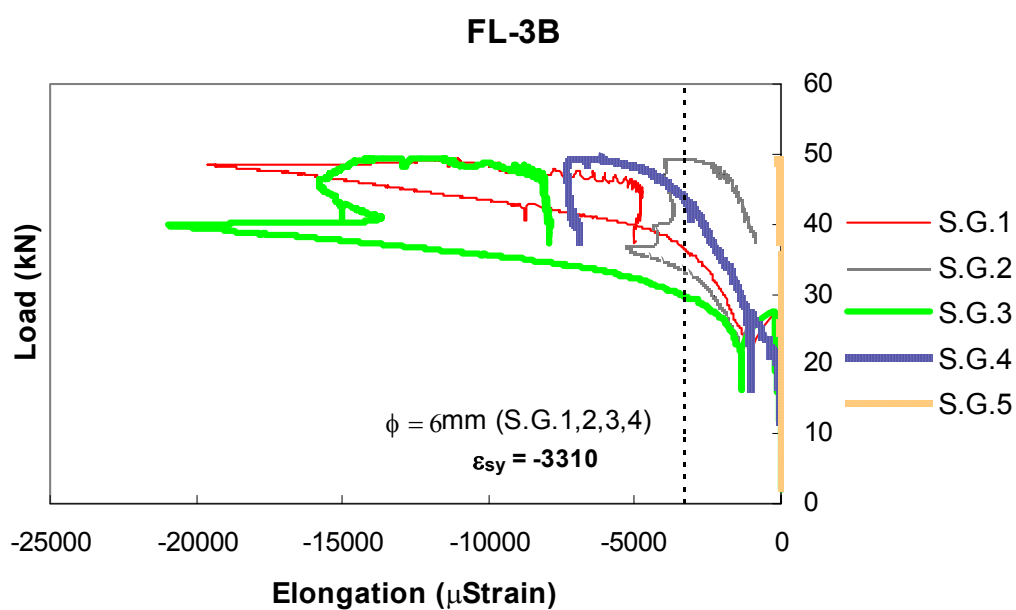
Figure 32 - Force-strain relationship for all strain gauges.

In this panel the strain gauges were placed according to the model 5 (see Figure 9). As expected, the strains in S.G.5 were reduced because it was fixed to a transversal bar, see Figures 34 and 35. The strain evolution indicates that crack propagation has coming from rear to front face of the panel. The strain decay on strain gauges S.G.2 and S.G.3, at a load of about 40 kN, was due to the slip of the corresponding longitudinal bars, in the moment when fissures 2 and 2' occurred.

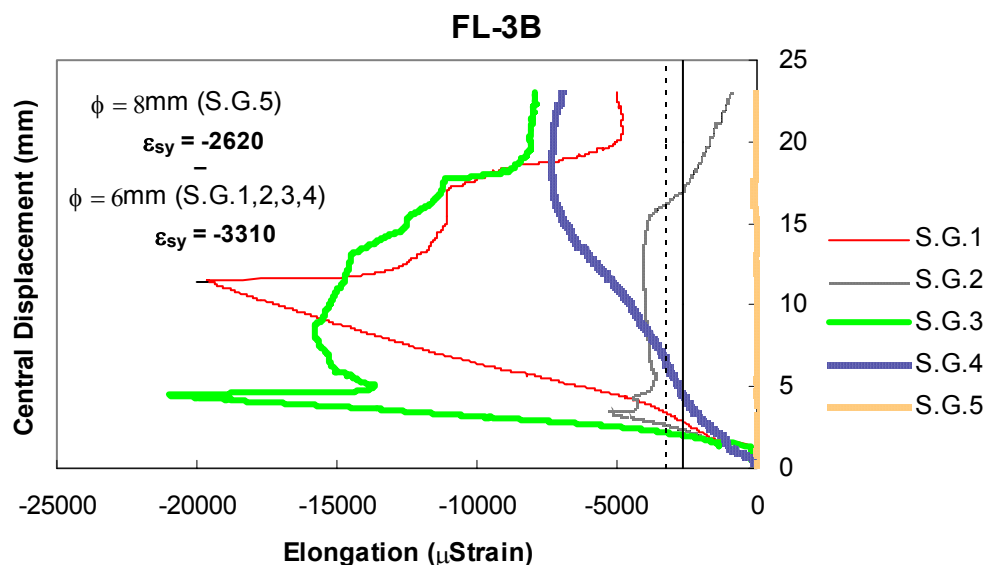
Figure 33 - Relationship between the deflection at panel mid span and the strains at strain gauges.

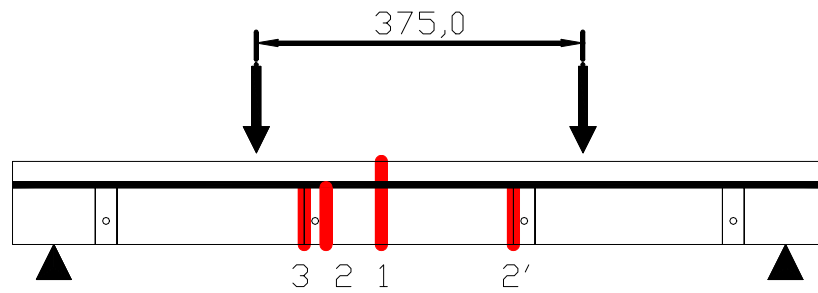
Figure 34 - Crack pattern in FL-4B.

Figure 34 represents the final crack pattern of panel FL-4B. Fissure 1 was the first one to occur, crossing the brick unit near the panel mid span, at a load level of 14 kN. At a load of 24 kN fissures 2 and 2' occurred simultaneously, followed by fissure 3 at a load of 41 kN. A significant decrease of stiffness at the moments corresponding to crack initiation of fissure 1 and fissures 2 and 2' can be detected from the force-deflection relationship, see Figure 35. Fissure 3 was the failure crack and its crack opening increased significantly at a load level of 54 kN. At a load of about 56 kN the crack opening of fissures 3 and 2' has also increased significantly, and the panel has ruptured.

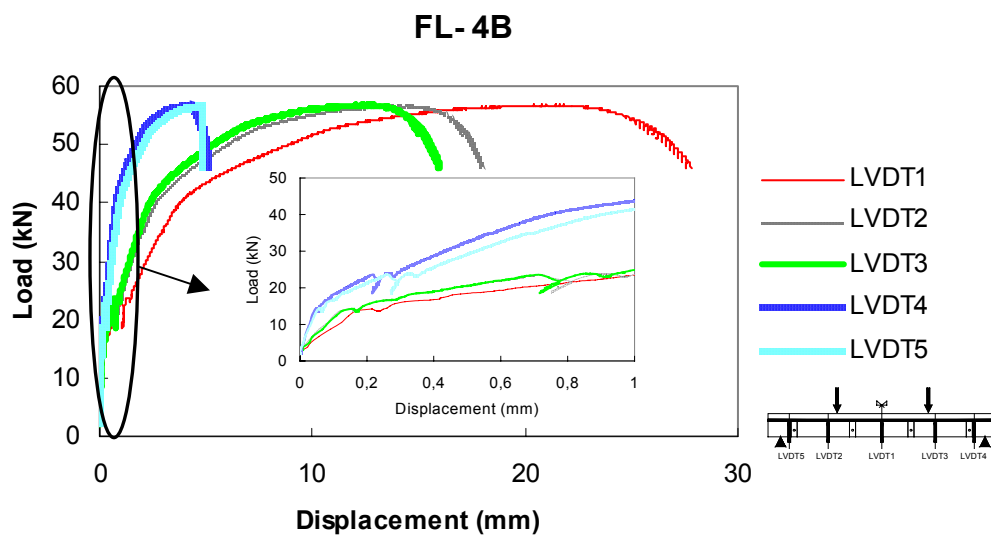
Figure 35 - Force-displacements relationship for all LVDTs.

Figure 35 represents the relationship between the force and the deflections registered in all LVDTs. The panel deformability was almost symmetrical, due to the regular crack pattern. At failure, panel FL-4B remained with the aspect shown in Figure 36.

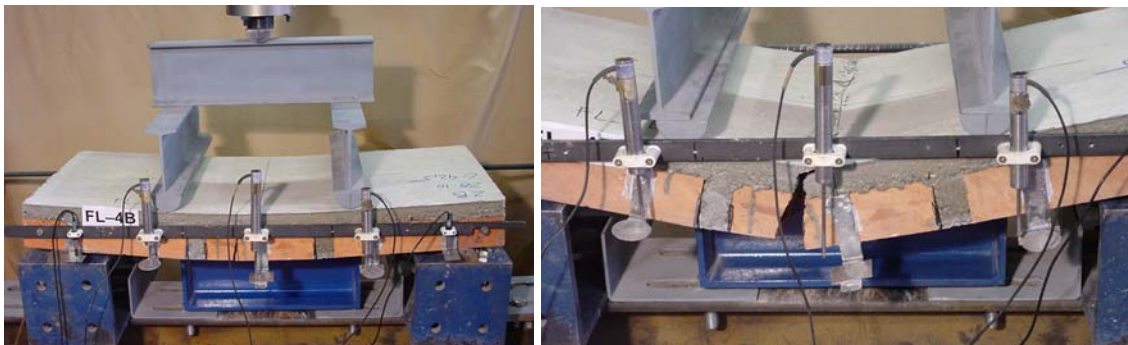
Figure 36 - Aspect of the panel FL-4B after have been tested.

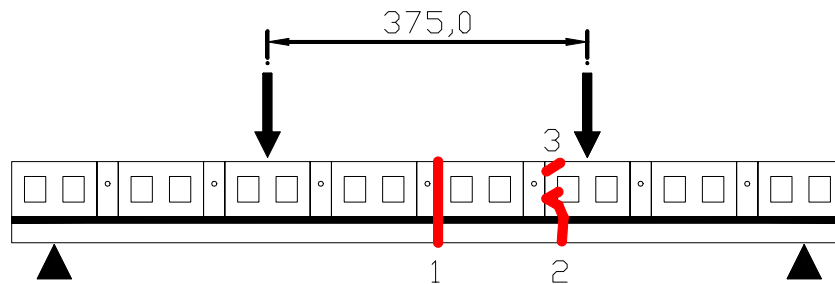
Figure 37 - Crack pattern in FLI-1A.

Panels of series FLI-A were similar to the panels of series FL-A, but were tested with the concrete layer turned downward. The first fissure (number 1, see Figure 37)

occurred at the central concrete/brick interface. After concrete layer have been cracked, the force deflection rigidity decreased up to the moment when wire mesh has yielded, which occurred at a load of about 20 kN. Near 27 kN the wire mesh have ruptured, having induced an abrupt load decay. At 30 kN the crack opening of fissure 2 increased significantly and break crushing ahead of crack 3 was observed.

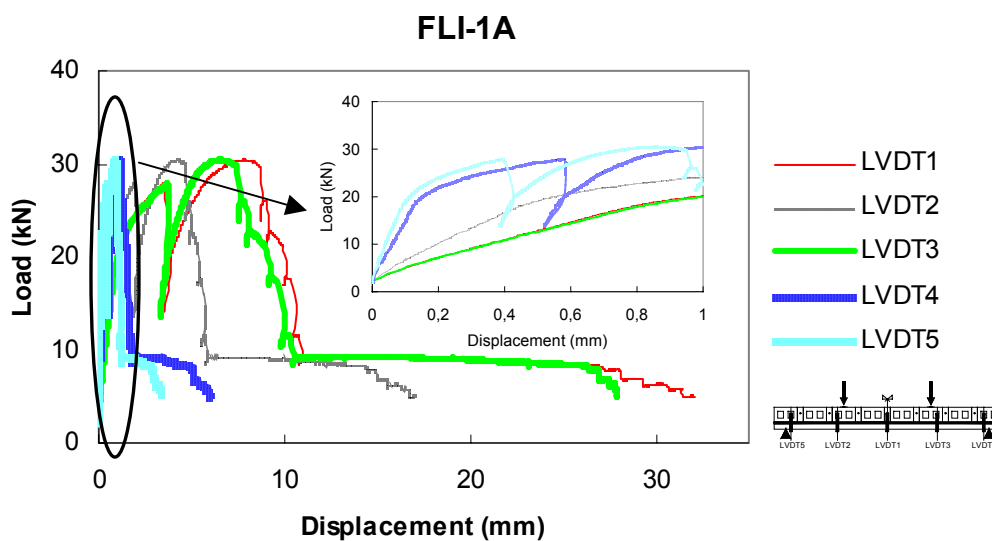
The relationships between the force and the displacements registered in the LVDTs are represented in Figure 38. LVDT 3 measured larger displacements than the transducer placed symmetrically to it (LVDT2) because LVDT3 was closer to the failure crack (fissure 2). Due to similar reasons, LVDT4 registered larger displacements than LVDT5. At failure, at panel front face, fissure 2 attained a crack opening of 15 mm and 10 mm at panel bottom surface and at concrete layer/brick interface, respectively. Figure 39 shows the failure mode of the panel FLI-1A.

Figure 38 - Force-displacements relationship for all LVDTs.

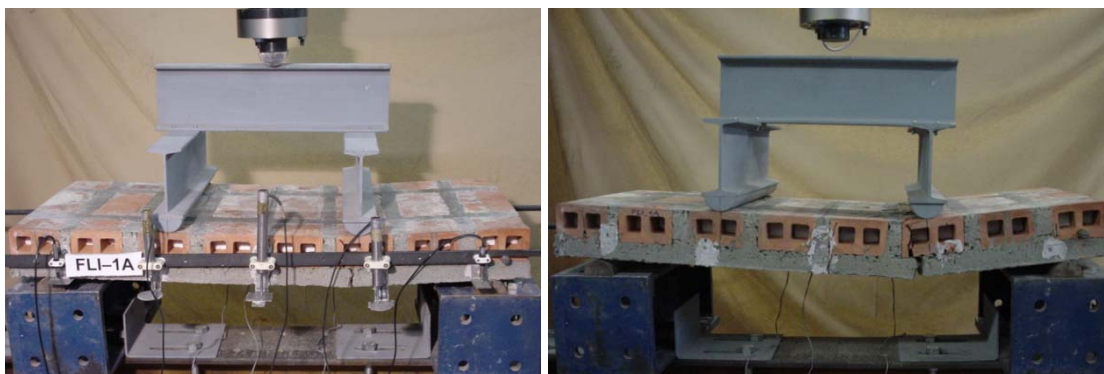
Figure 39 - Aspect of the panel FLI-1A after have been tested.
